# Manhole Inspection Summary

Manhole # S29YY\_001MH

**Location** Address: **3100 33RD ST**

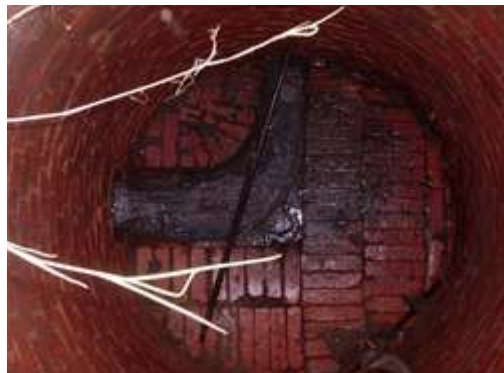
Top View

Corroded steps. Evidence of surcharge - Bench debris.

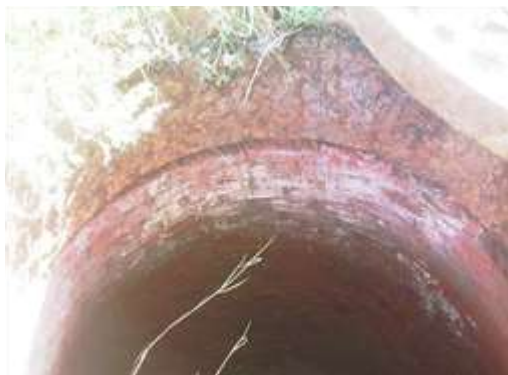
Defect

Adjustment deterioration and infiltration. Corbel and Barrel infiltration - other side.

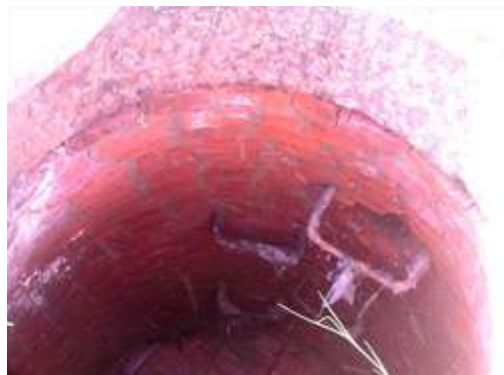
Defect

Adjustment deterioration and infiltration. Corbel and Barrel infiltration

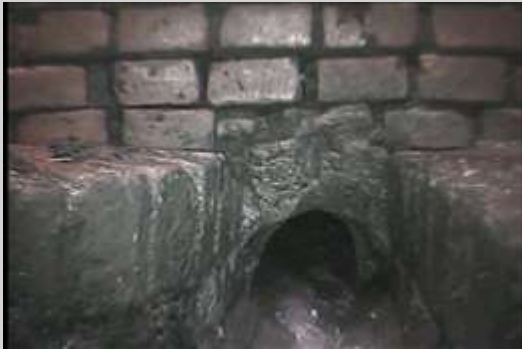
### 10 in. Circular Gravity Sewer Pipe Out @ 12 O'Clock

Barrel deterioration and infiltration.

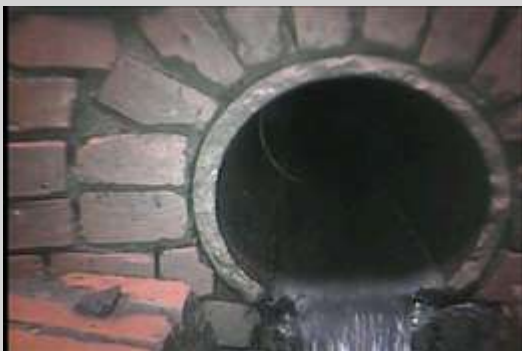
### 10 in. Circular Gravity Sewer Pipe In @ 9 O'Clock

Infiltration: **Evidence** Pipe Seal Cond: **Unknown**
